*Review of Florida's
Investor-Owned Electric Utilities' Service Reliability
In 2008*

Florida Public Service Commission
Division of Service Quality, Safety, and Consumer Assistance

December 17, 2009

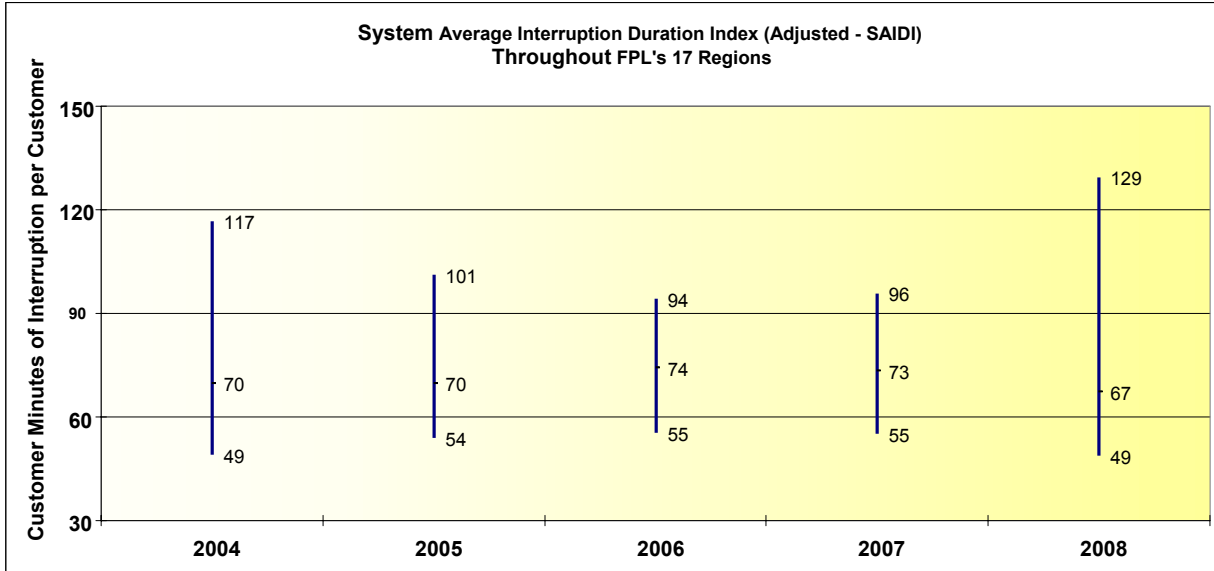
Figure 3-1. SAIDI Across FPL's 17 Regions (Adjusted)

Figure 3-1 shows the maximum, average, and minimum adjusted SAIDI (minutes of interruptions per customer) recorded across FPL’s system that encompasses five management regions with seventeen service areas. The maximum and minimum SAIDI values are the values reported for a particular service area. While Figure 3-1 shows a general decrease in the minimum SAIDI to 49 minutes for the Pompano service area, there is also a significant increase in the maximum SAIDI to 129 minutes for the North Florida service area. Since 2004, FPL’s system average has decreased slightly from 70 minutes to 67 minutes. FPL attributes the massive blackout on February 26, 2008, to adding nine minutes to the SAIDI reliability indicator for 2008.

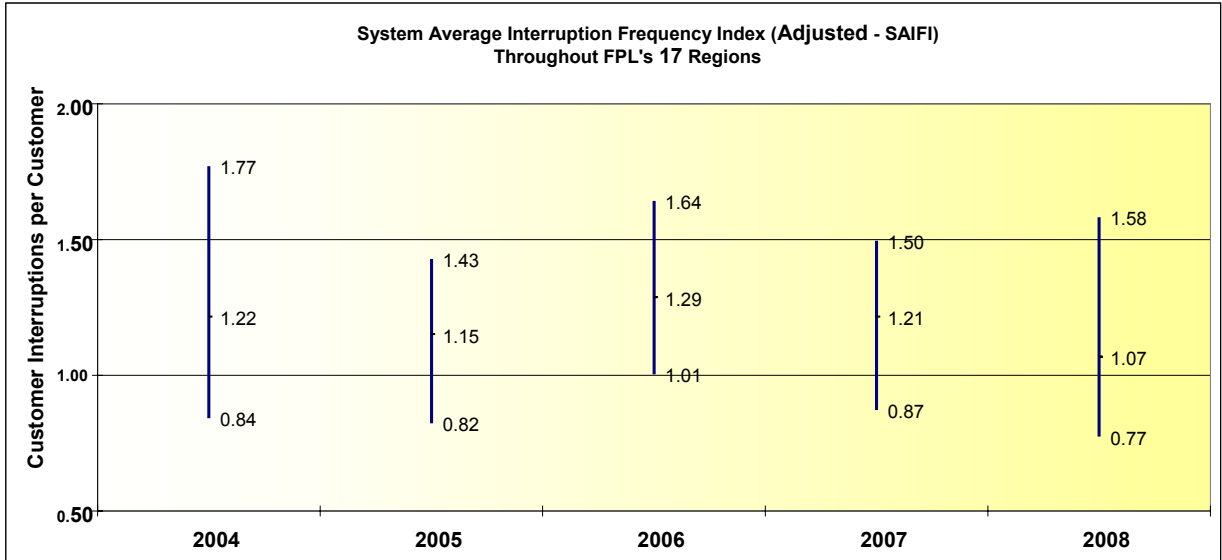
Figure 3-2. SAIFI Across FPL's 17 Regions (Adjusted)

Figure 3-2 is a chart of the maximum, average, and minimum adjusted SAIFI (frequency or number of interruptions per customer) across FPL’s system. FPL achieved its best SAIFI since 2004 with a system average of 1.07 service interruptions per customer in 2008. FPL reported a declining SAIFI for the Treasure Coast and Toledo Blade service areas, suggesting a general improvement in these areas which historically have received less reliable service compared to other FPL regions.

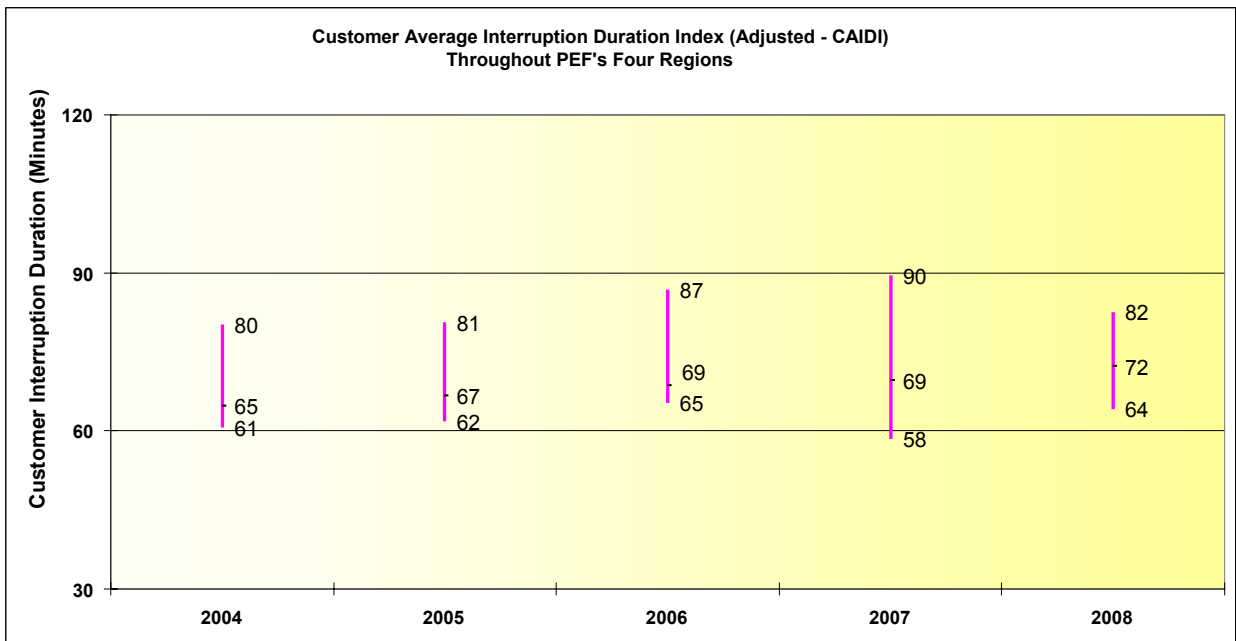
Figure 3-11. CAIDI Across PEF's Four Regions (Adjusted)

Figure 3-11 is the maximum, average, and minimum adjusted CAIDI (outage restoration time) across PEF's region. PEF's adjusted average duration of service interruption has risen approximately ten percent from 65 minutes in 2004 to 72 minutes in 2008. The North Coastal region has continued to have the highest CAIDI level for the past five years over all of PEF's regions, while the South Coastal region has maintained the lowest CAIDI level during the same period.

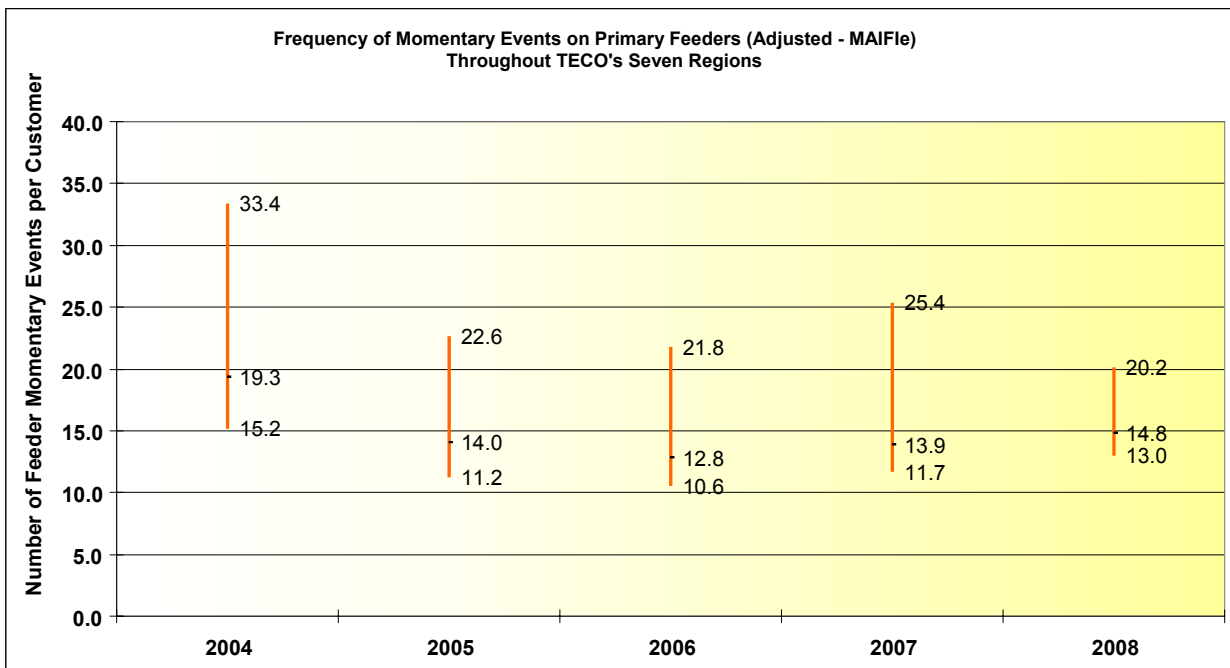
Figure 3-21. MAIFle Across TECO's Seven Regions (Adjusted)

Figure 3-21 shows the maximum, average, and minimum adjusted MAIFle (frequency of momentary events on primary circuits per customer) recorded across TECO's system. TECO reported a continued increasing MAIFle in 2008, a trend suggesting an increase in the number of feeder momentary events compared to the prior two years.

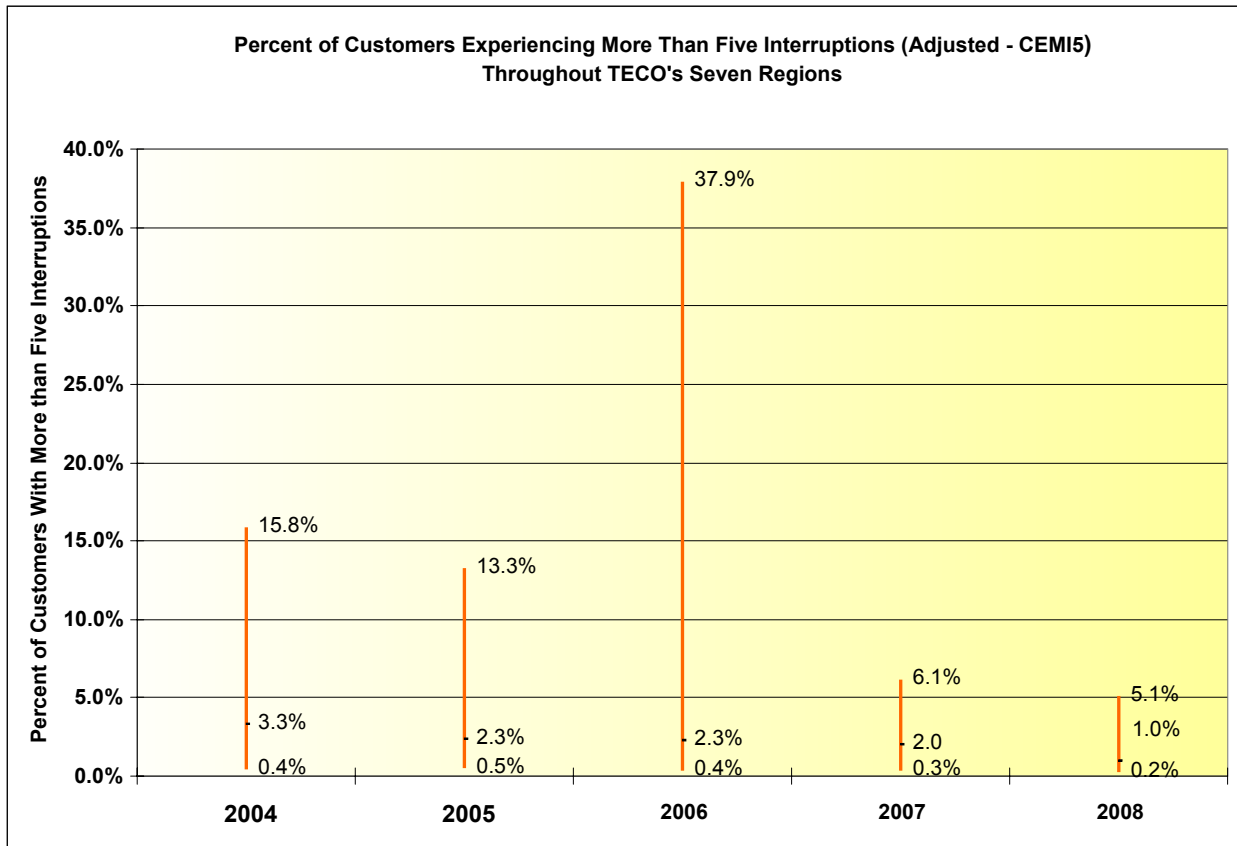
Figure 3-22. CEMI5 Across TECO’s Seven Regions (Adjusted)

Figure 3-22 shows the maximum, average, and minimum adjusted CEMI5 and there appears to be an increasing difference between the average and the maximum levels of reliability to regions of customers throughout TECO’s system. TECO’s Dade City and Plant City regions had the highest recorded CEMI5 values, totaling 72 percent of the CEMI5 value for TECO’s seven regions. In addition, these two regions have the highest SAIDI, SAIFI, and MAIFIE indexes of the seven regions.
